PROJECT PROGRESS REPORT

**PREPARED FOR THE ALASKA ENERGY AUTHORITY BY
THE ALASKA CENTER FOR ENERGY AND POWER**

PROJECT TITLE: *Round 1: Emerging Energy Technology Fund – Data Collection*

REPORTING PERIOD: 4th Quarter 2014

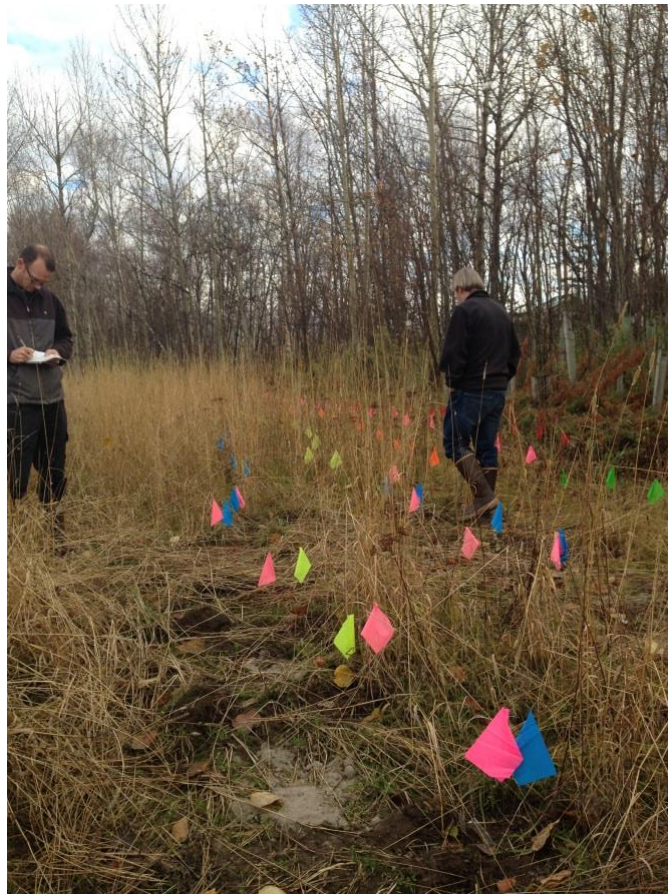
Figure 4: Pin flags marking poplar cuttings can be seen at one of the study sites.

The different poplar varieties were marked with different colored pin flags as detailed in Table 1. For each site, the percent survival and growth heights were measured.

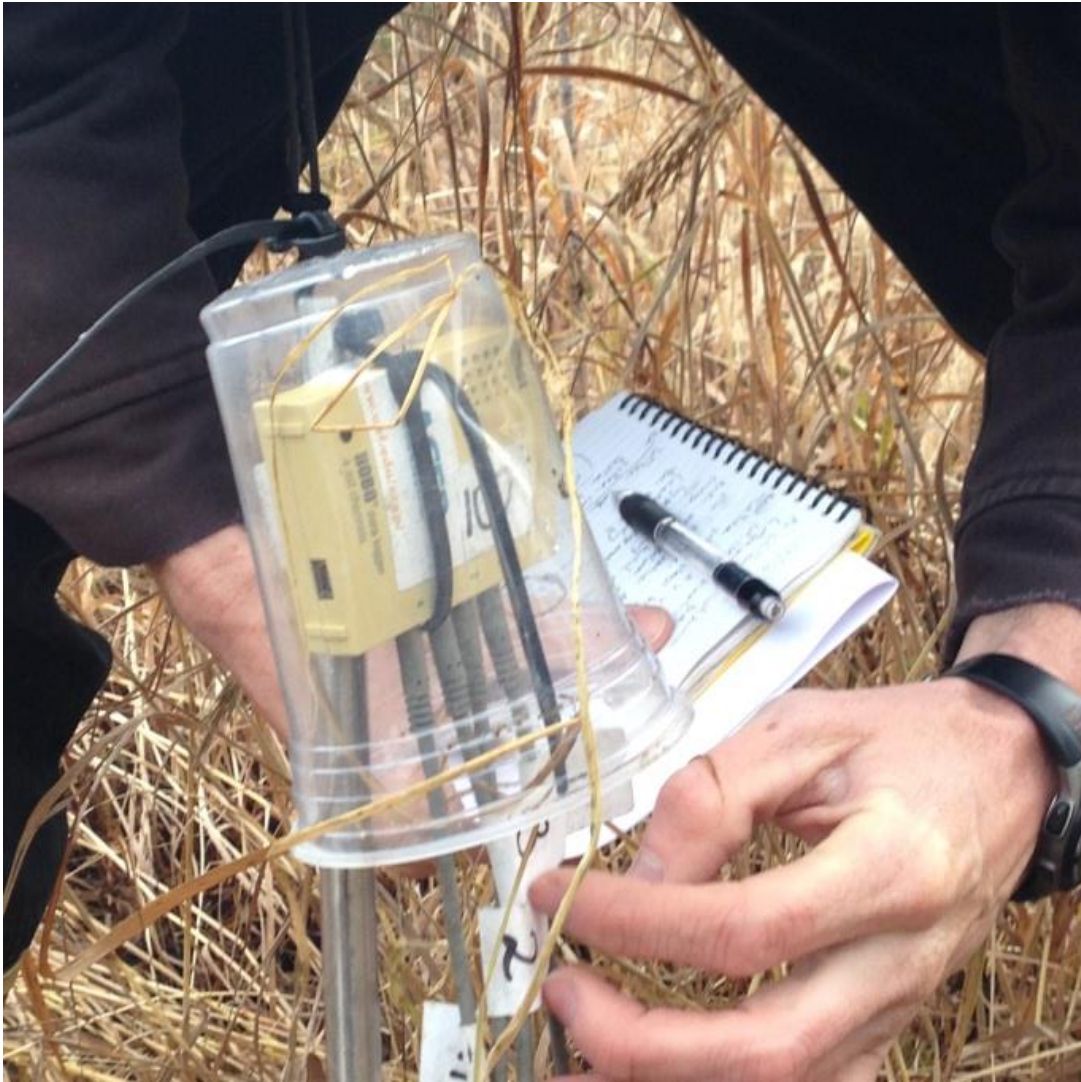
Figure 5: A Hobo data logger is retrieved from the field. Once back at the ACEP lab, the year's worth of temperature data was downloaded and analyzed.
